RAILWAY ACCIDENT INVESTIGATION REPORT

Occurrence of casualties among passengers of 7 up Tinsukia Mail train at Km./77/3-4
between Pathsala and Tihu Stations on the Single Line New
Bongaigaon Gauhati Metre Gauge Section of
Alipurduar Division of Northeast
Frontier Railway at
13-09 hours

12 th March, 1981

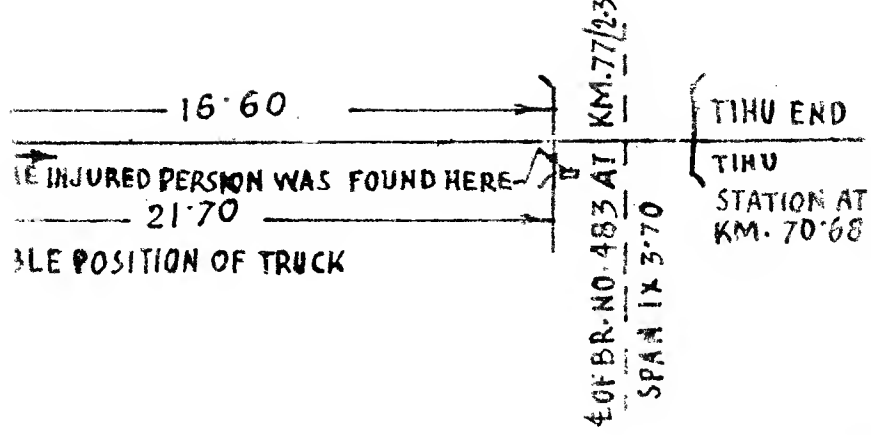
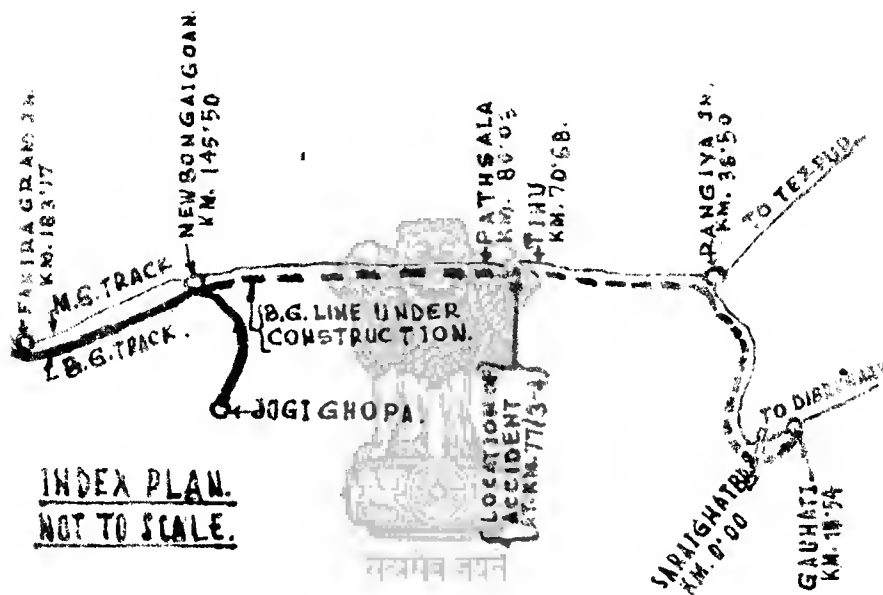
SECTION SHOWING PROBABLE POSITION OF COACH AT
AT THE TIME OF ACCIDENT.
SCALE - 2CM=1M.

fouling the metre gauge track. In the present case the truck was close enough to cause injuries to passengers who had kept their limbs projecting outside the window but it was far enough not to come in contact with the body of the coach.
